SUMMARY OF FINDINGS – EXTERIOR

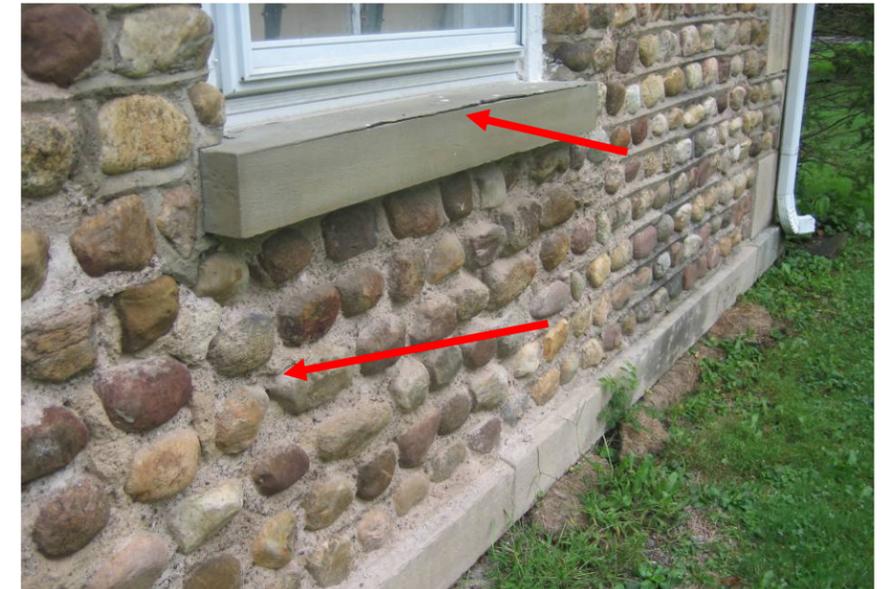
Overall the masonry is in good condition; select repointing was completed in 2000. However, mortar deterioration is still evident where water is washing over the cobblestone, due to undersized and failing roof drainage, and under window sills lacking a proper drip edge. Minor cracks and delamination were noted at limestone window sills.

Image III- 1: East elevation of east wing showing mortar deterioration and delamination of window sill.

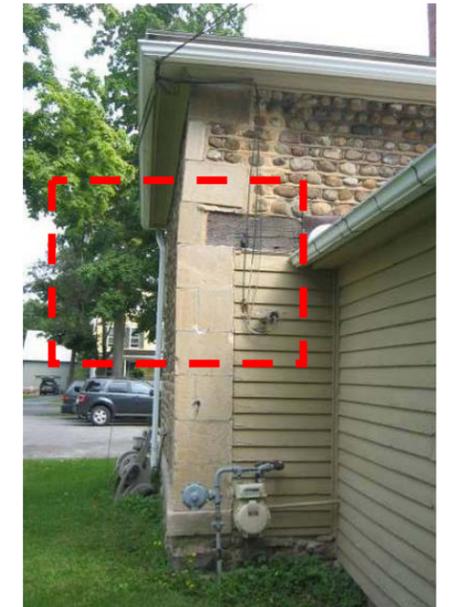
At the southwest corner of the west wing there is a pronounced bow in the cobblestone wall at the bearing end of the existing heavy timber header. The movement was likely caused by a previous modification of the masonry opening that was not properly shored during construction. There is no visible evidence of cracking or distress in the mortar joints, indicating the movement may be stabilized.

Image III- 3: Structural movement at southwest corner of west wing

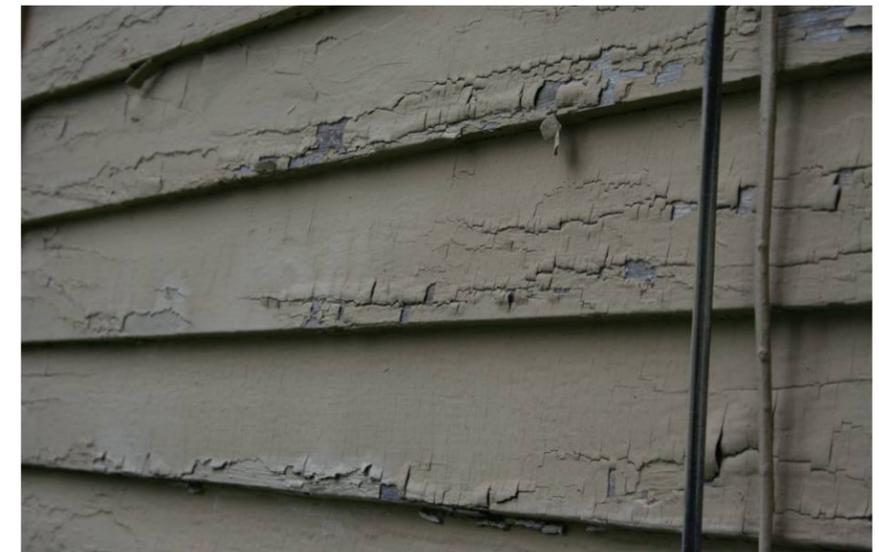
Wood clapboard siding covers the 1871 addition, the connector hyphen between the west wing and the 1871 addition, and the 1916 addition. Overall, it is in good condition with areas experiencing varied degrees of paint deterioration. Vertical board and batten siding covers the contemporary additions and is in good condition, although several battens are cracked or missing.

Image III- 5: Typical deterioration of painted finish at clapboard siding

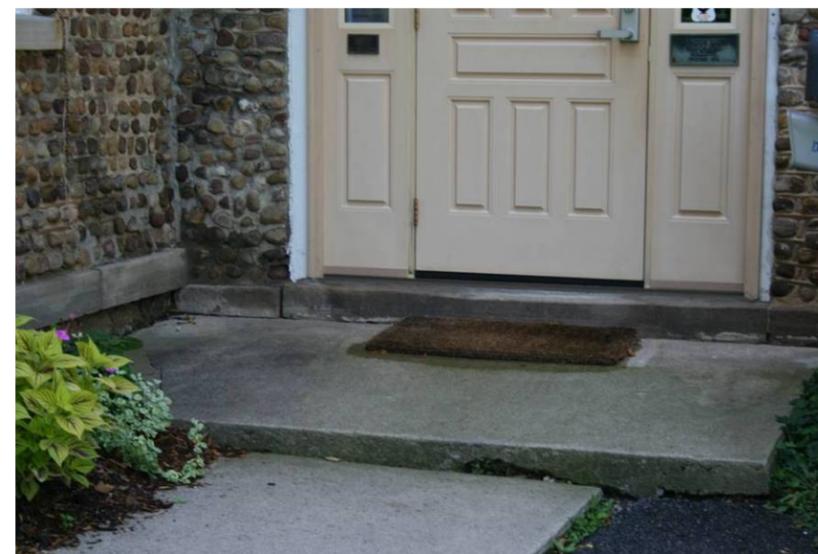
There is currently no wheelchair accessible route from the parking lot into the building. All entrances have steps up into the building wings.

Image III- 4: Inaccessible Main Entrance at the west wing, part of the original ca. 1838 cobblestone schoolhouse

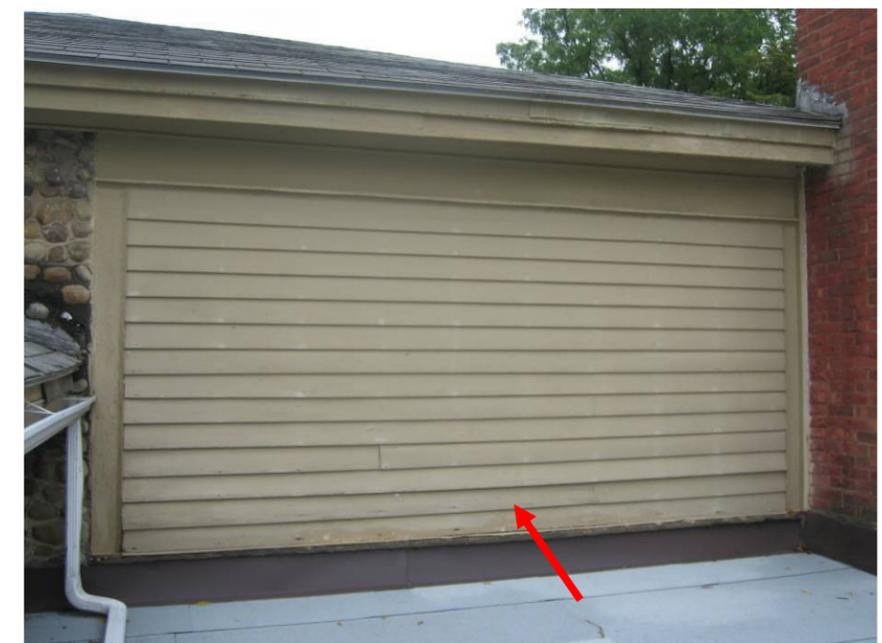
The area of wood clapboard sided infill on the west elevation of main cobblestone building is showing signs of severe water damage and deterioration. The current state allows water to infiltrate into the building and is the probable cause of water damage to the interior of the Middle Room and the West Hall below.

Image III - 6: Deteriorated clapboard clad framed infill on west elevation of main block

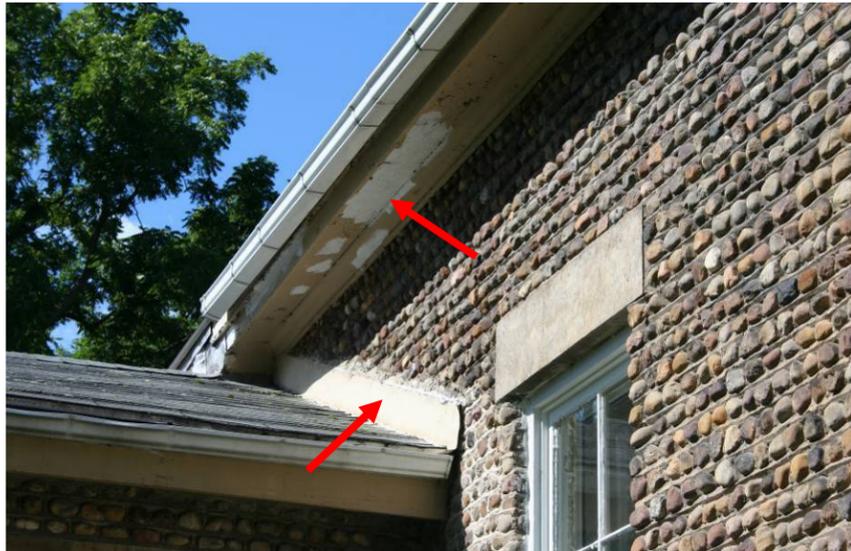
Exterior wood soffit and trim at the cobblestone building is in overall good condition with areas of deterioration due to moisture infiltration resulting from paint failure.

Image III- 7: Deteriorated wood cornice and soffit. Also shown is improper wall flashing.

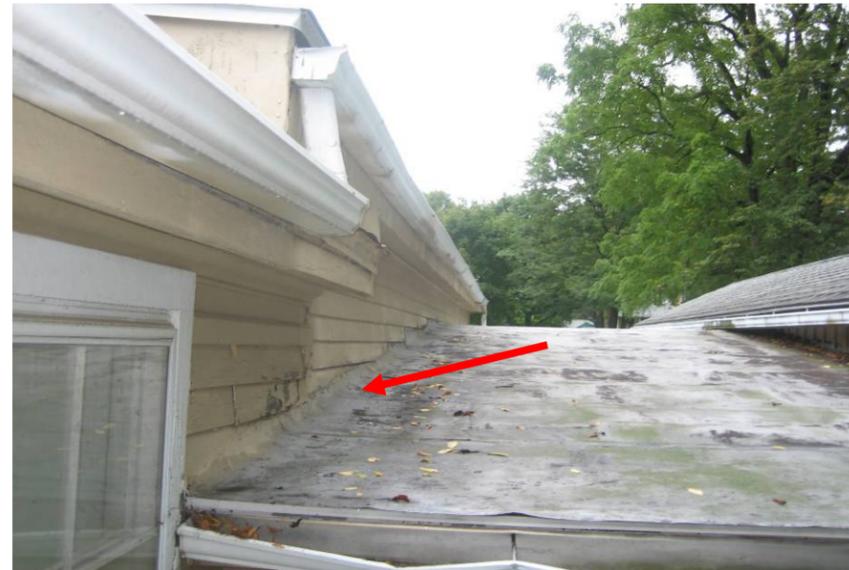
The Annex has asphaltic roll roofing nearing the end of its useful life and has been improperly flashed at wall connections. The Coach House addition has a gabled roof with asphalt single roofing in poor condition.

Image III- 9: Annex addition roof, note condition of the roof covering and improper wall flashing

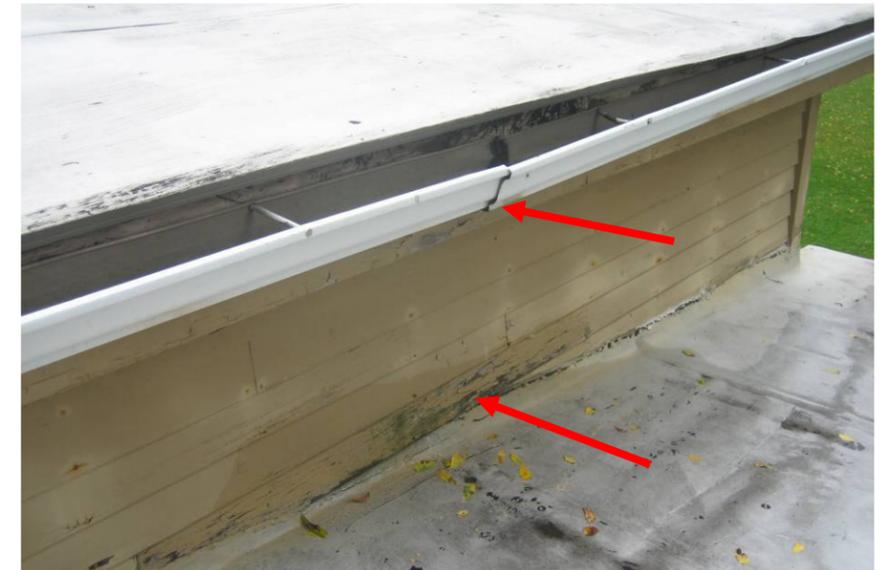
There are several areas where gutter and downspouts have disconnected allowing water runoff on building. Gutters and downspouts along the east side of the building's rear additions are possibly under-designed for the volume of runoff, evident in moisture damage at wood soffits and trim and deterioration of mortar from water flowing down the side of the building.

Image III-11: Disconnected and uncovered gutter at 1968 Memorial Room Addition

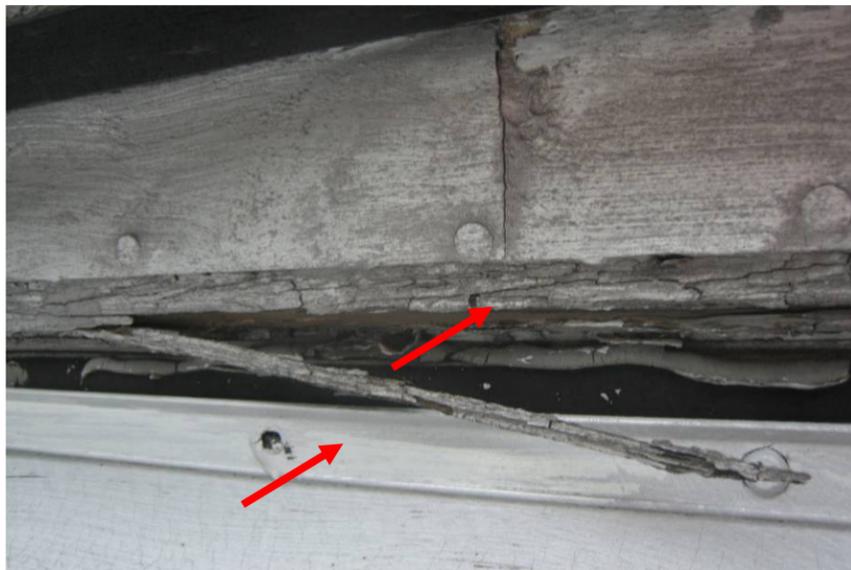
Image III- 8: Deterioration of wood at termination of 1968 addition (Memorial Room) roof at cobblestone wall.

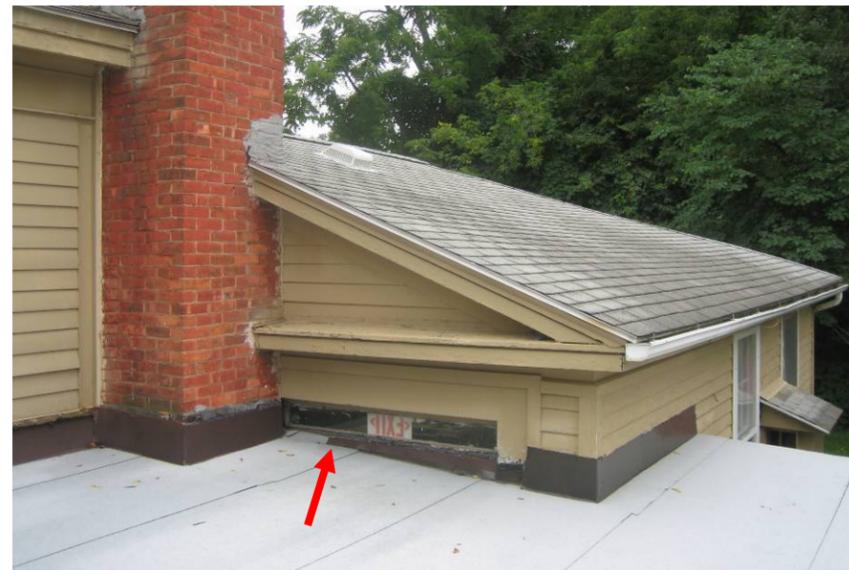
The hyphen addition's shed roof was replaced in 2008 with self adhered roll roofing. It was reported by the Society that ice damming occurs during winter months. Flashing has been

improperly installed at complex intersections at the chimney and original exterior door assembly of the 1871 addition.

Image III-10: Improper flashings at hyphen addition roof at intersection with 1871 addition.

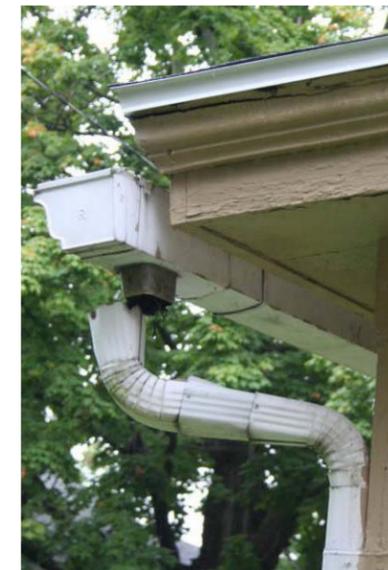
Image III- 12: Disconnected downspout at connector addition.

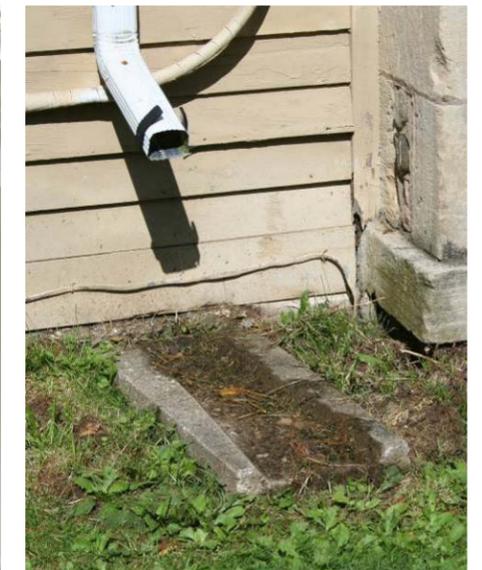
Extenders have been added to downspouts in an attempt to discharge water away from the building. Poor grading in several areas is resulting in water traveling towards building foundation.

Image III- 13: Water discharge at building foundation.

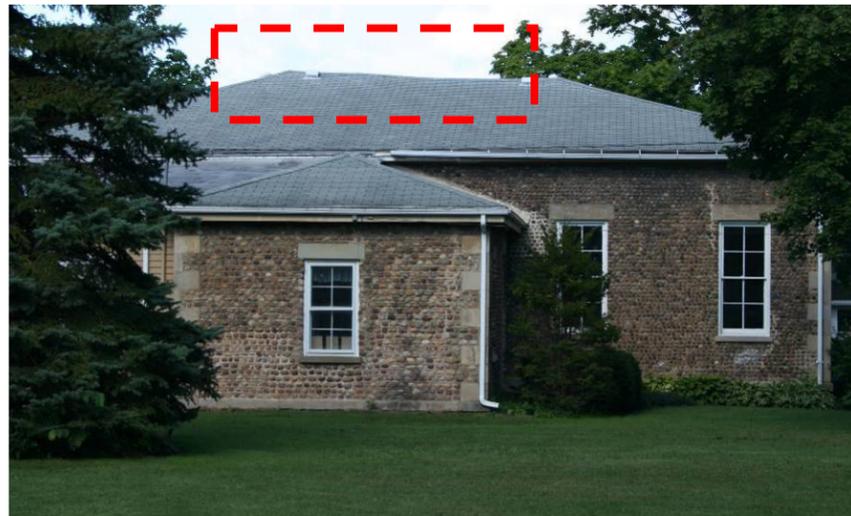
There is visible structural deflection at the ridge line of the roof and this movement is likely caused by several factors. First, roofs typically experience some movement over time. Next, there are not many visible connections between main framing members and failure could be occurring at these connection points. Lastly, the main ridge board has been cut in two locations rendering it ineffective.

Image III- 14: Sagging of ridge at hipped roof of main block

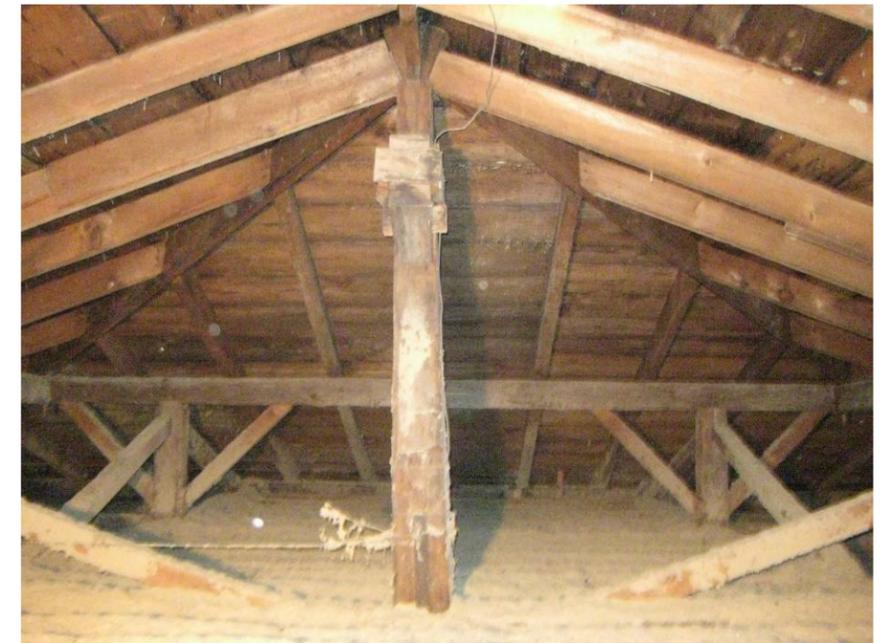
The structural failures at the roof structure appear to be the cause of the visible sag in the Auditorium's vaulted wood ceiling below. This condition appears to be specifically related to movement of the north king post of the roof structure.

Image III- 16: View of roof structure of main block looking north over ceiling of Auditorium. Showing north king post which is most likely cause of sag in barrel vaulted ceiling below.

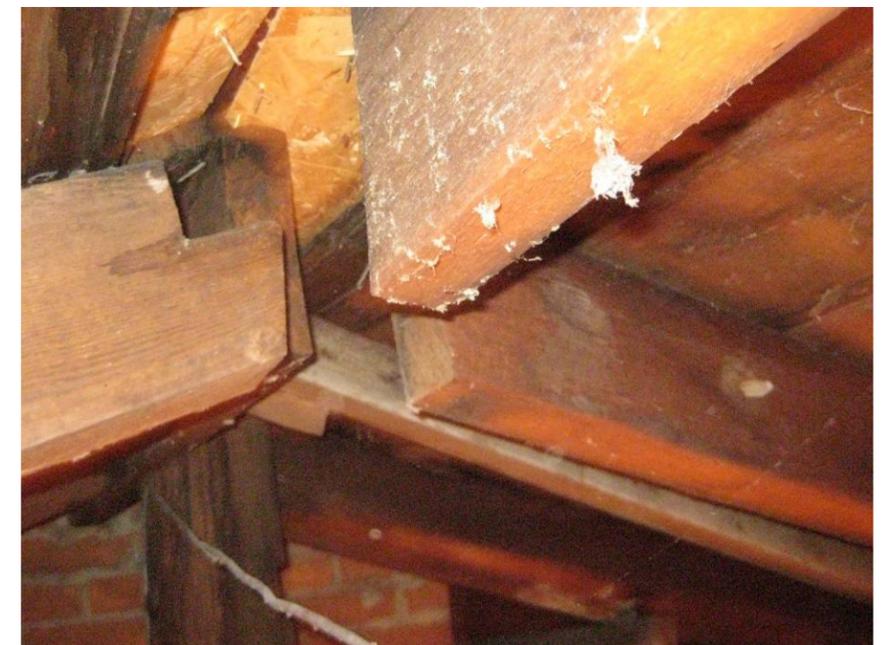
Image III- 17: Missing section at main ridge board.

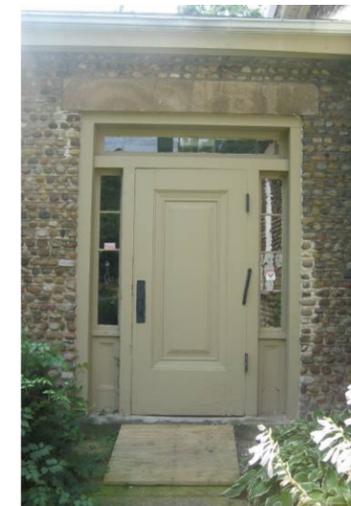
The original ca. 1838 entrance of the east wing features a solid wood door with single raised panel with rectangular, single glazed transom and sidelights. The assembly is in overall good condition, save some cracked glass and missing panel trim.

Image III: 21 – Original entrance door at east wing

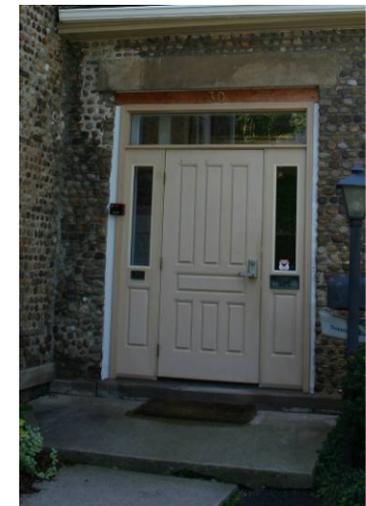
The main entrance is through the west wing and has been retrofitted with a contemporary door ca. 2004. Originally this opening would have held a mirror replica of the door assembly still extant on the north façade of the east wing.

Image III: 22 - Replacement entrance door at west wing
