SUMMARY OF FINDINGS – INTERIOR

INTERIOR FINISHES

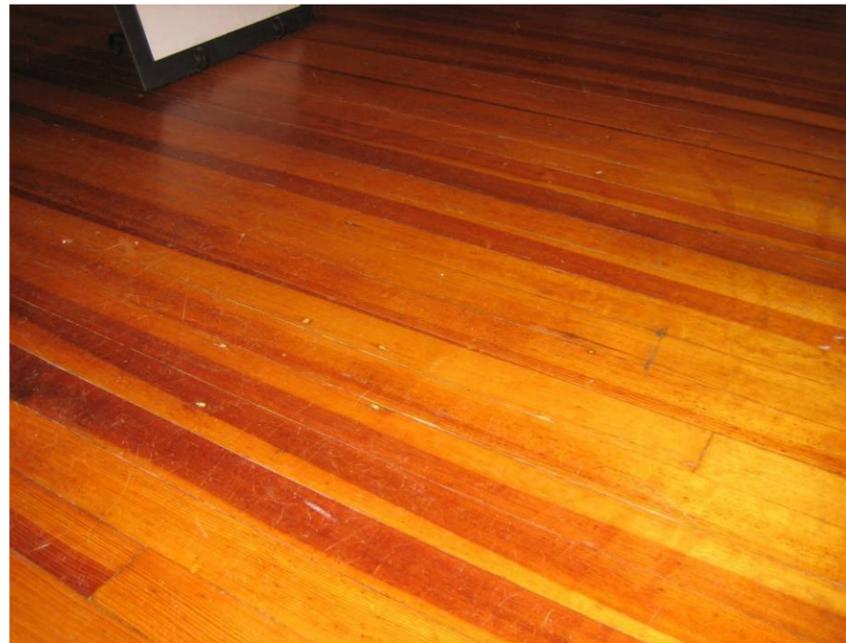
Historic spaces feature wood floor framing with finished hardwood flooring. The Auditorium floor has been refinished with the remaining hardwood flooring retaining the worn patina of over 170 years of use.

Image III- 23: Refinished flooring at Auditorium

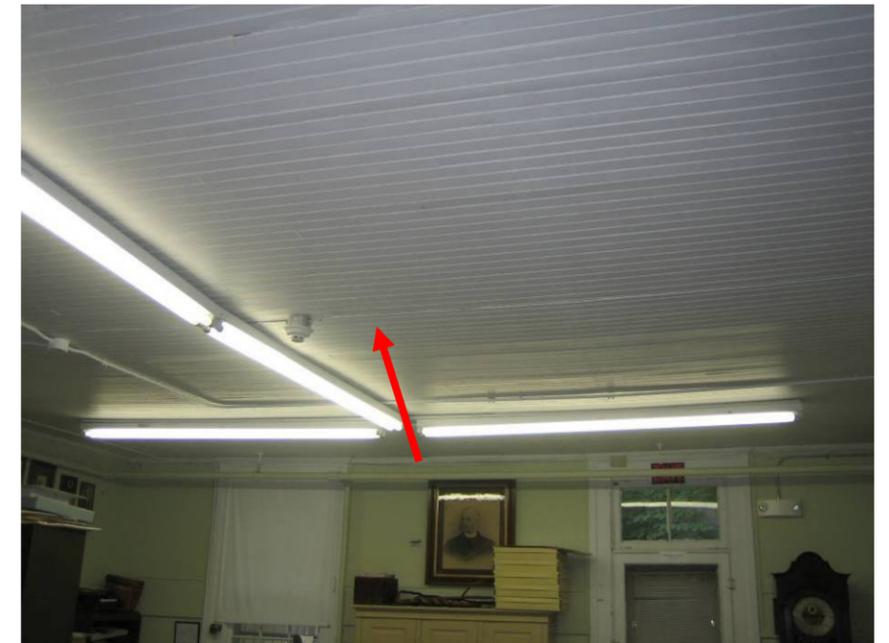
Image III- 25: Deflection of wood ceiling of 1871 addition (office)

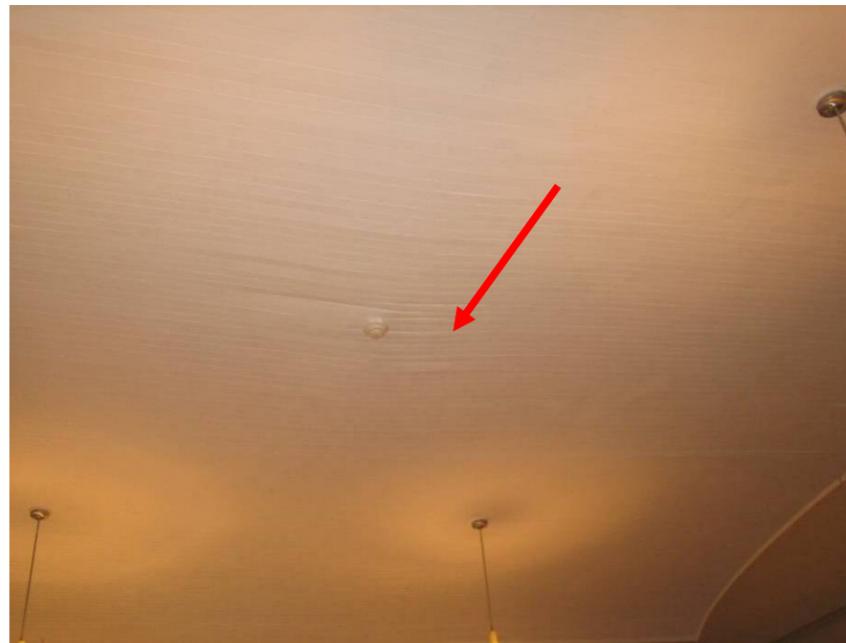
Historic spaces feature either painted plaster or wood ceilings primarily finished with a simple cove wood molding. There are areas of water damage at the wood ceiling of the Middle Room evident in cracked and peeling paint. The ceiling in the Auditorium is a barrel vaulted wood ceiling that is sagging from structural movement of the roof structure above. The Office (1871 Addition) is exhibiting slight sagging in the wood ceiling and should be further monitored. A suspended acoustical ceiling is installed in the east wing concealing the original plaster ceiling above. Although there is no evidence of active leaking, the plaster ceiling in the East Hall has suffered severe water damage presumably from a previous roof leak.

Image III- 24: Deflection of wood ceiling of Auditorium

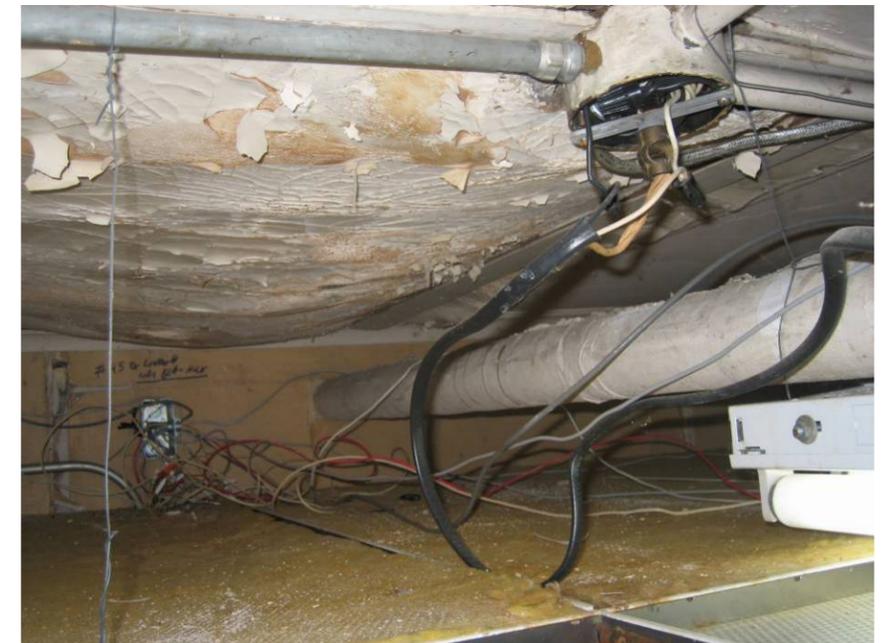
Image III- 26: Water damage of ceiling above suspended ceiling in east hall. Note exposed electrical wiring.

Room:	East Hall
Use:	Circulation/ Exhibits
Size:	7'-8" x 15'-0" 115 SF
Flooring	
Description:	Hardwood
Condition:	Good
Notes:	Worn finish
Wall Finish	
Description:	Painted plaster
Condition:	Fair
Notes:	Deteriorated plaster and painted finish at walls above suspended ceiling due to water infiltration
Ceiling	
Height:	Approximately 9'-0" A.F.F.
Description:	Suspended acoustical tile ceiling concealing original flat plaster ceiling above
Condition:	Poor
Notes:	Severe water damage to original plaster ceiling above suspended ceiling
Trim	
Description:	Plain wood base, door casements, and chair rail molding ; small cove ceiling molding above suspended ceiling
Condition:	Good
Notes:	Surface wear and multiple layers of paint; Ghosts of children's coat hooks are present at original chair rail moldings
Additional Notes:	- Exposed wiring present above suspended ceiling - No dedicated heat source

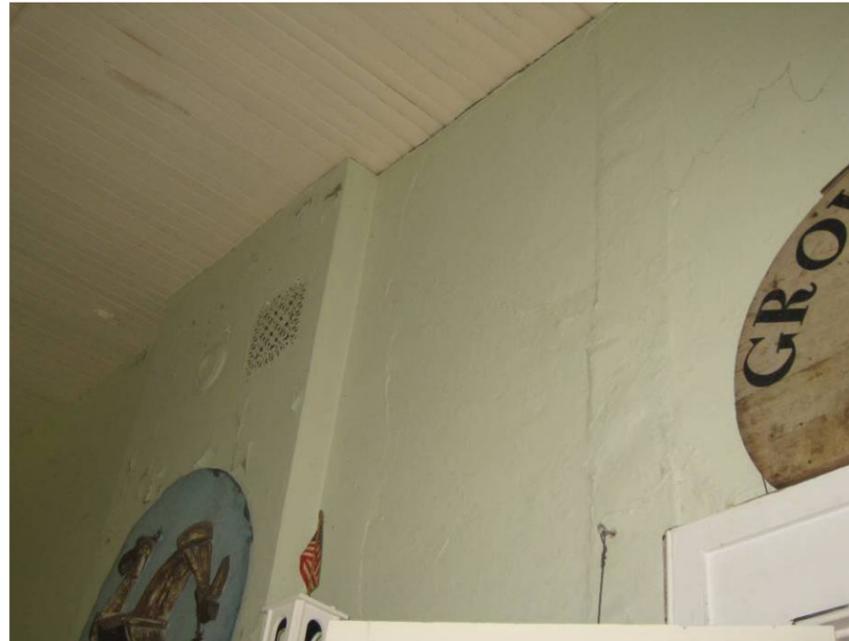
Overall, the plaster and wood trim have been well maintained and are in good condition. There are areas of water damage at plaster walls in Middle Room. evident in cracked and peeling paint. Damage to the north wall appears to have been caused by a leak in the approximate location of a central chimney that has since been removed. The damage at the west wall has been caused by water infiltrating through failing exterior wood clapboard framed insert into west wall of cobblestone, visible above west shed roof addition.

Image III- 27: Damage to painted plaster finish on north wall of Middle Room

Wall Finish	
Description:	Painted plaster
Condition:	Fair to Poor
Notes:	Condition could not be fully assessed due to amount of exhibits concealing surface ; Deteriorated plaster and painted finish in multiple areas due to water infiltration; areas of greatest damage are at west wall from water entering through wood frame infill in cobblestone wall and on north wall from water presumably entering from former chimney penetration at roof

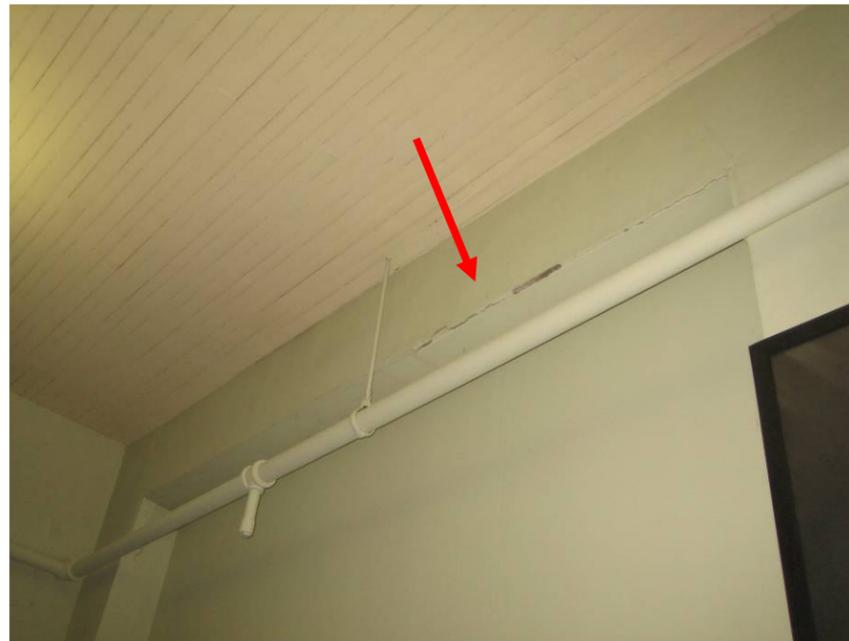
Image III- 28: Damage to painted plaster finish on west wall of Middle Room

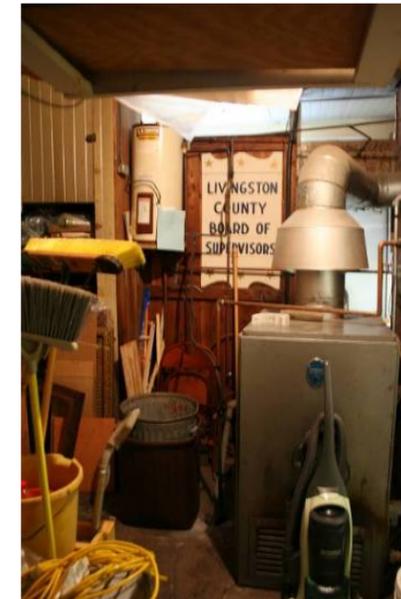
The mechanical system is a hydronic hot water system that currently heats the schoolhouse and the historic additions through the use of radiators. The boiler is located in the utility room, in the west wing, and is 20 plus years old and inefficient by current standards. The 1968 Memorial Room addition is heated by three electrical wall heaters while the 1968 Coach Room and 1973 Annex additions have no heating or ventilation systems.

Image III- 32: Outdated boiler

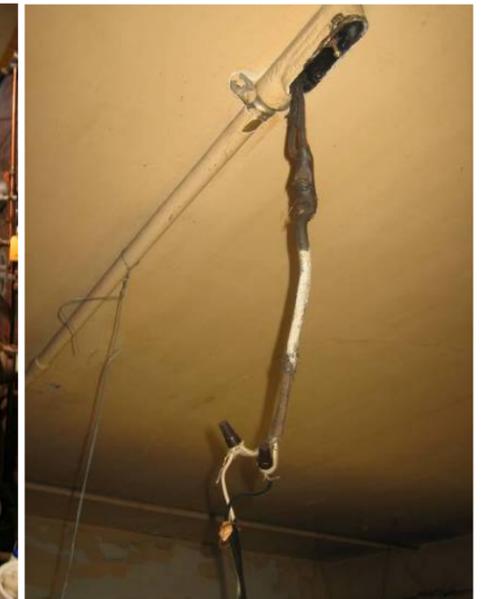
The building is illuminated with a combination of strip fluorescent and incandescent fixtures. Exposed wiring was noted above the east wing suspended ceiling.

Image III- 33: Exposed wiring at east wing above suspended ceiling

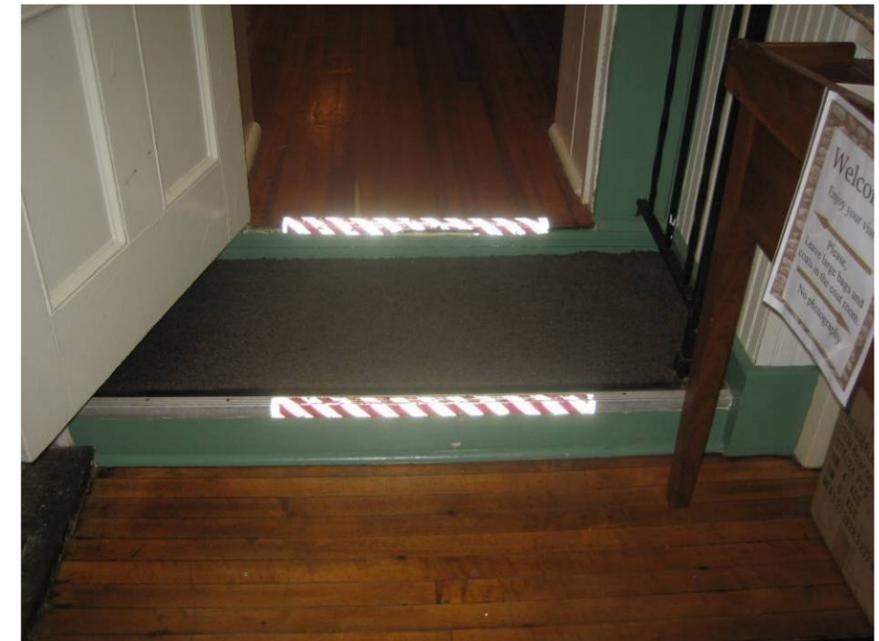
Visitors encounter a step up to the main entrance door in the west wing of the building, then immediately face two small steps up to the Auditorium which houses the main exhibit space of the Museum. These steps are difficult to navigate due to the short rise of each step, thus creating a tripping hazard. The main block of the building and 1968 Memorial Room addition rest approximately 9 inches above the flanking side wings which contain the building entrances. The rear Coach Room and Annex additions step down from the Memorial Room another 12 1/2 inches. These factors make it difficult for a disabled person to navigate through building.

Image III- 34: Steps from main entrance in the west wing up to the Auditorium that serves as the main exhibit space

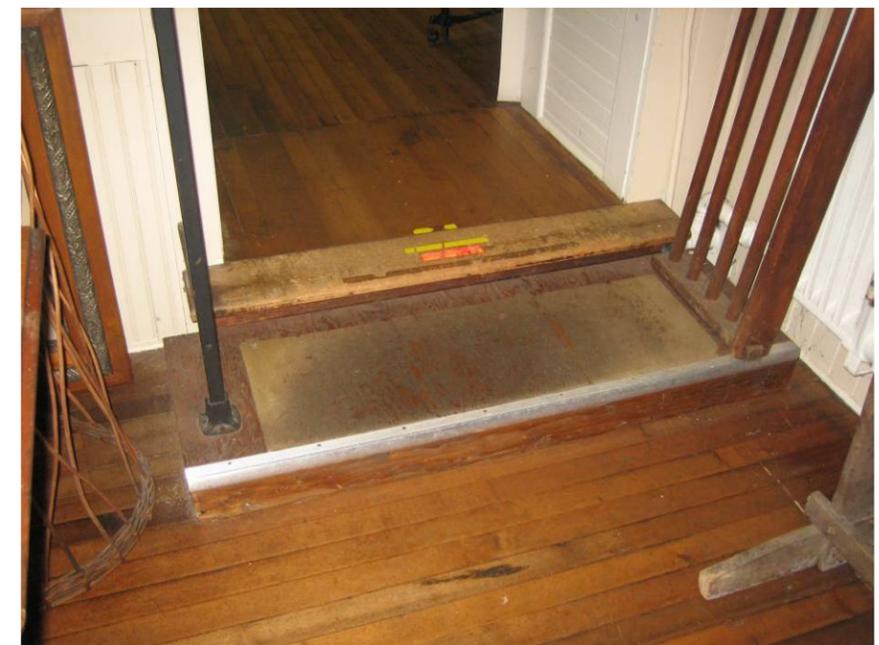
Image III- 35: Steps from Pioneer Room up to Middle Room

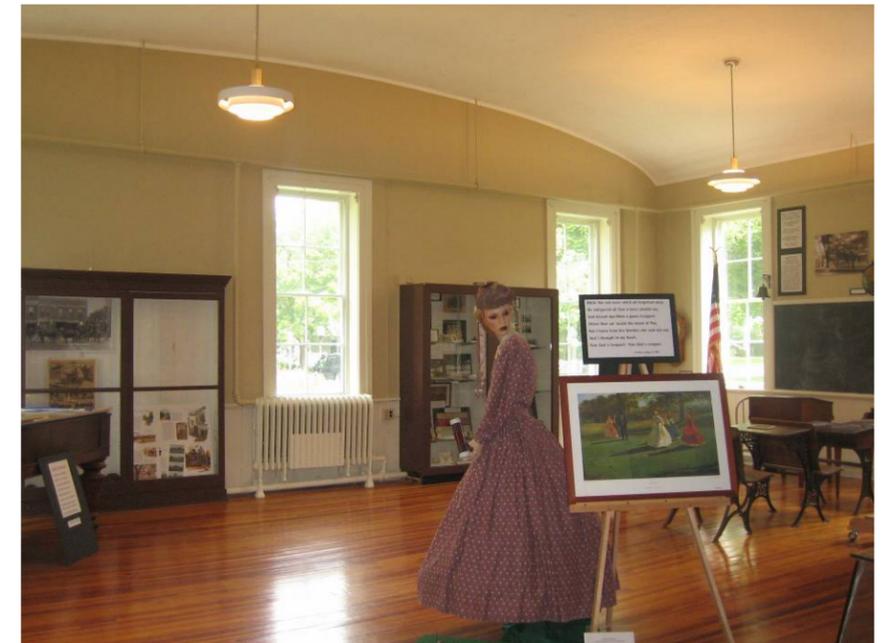
The Museum has made an effective effort to protect some objects on exhibit from excessive light with the UV-filtered interior storm windows installed in the Auditorium. However, not all windows are filtered, so UV exposure is still significant for objects in other spaces. In addition, light levels are too high in many areas, both from window light and from spotlights directed onto individual objects.

Image III- 37: Auditorium exhibit space where UV-filtered storm windows have been installed.

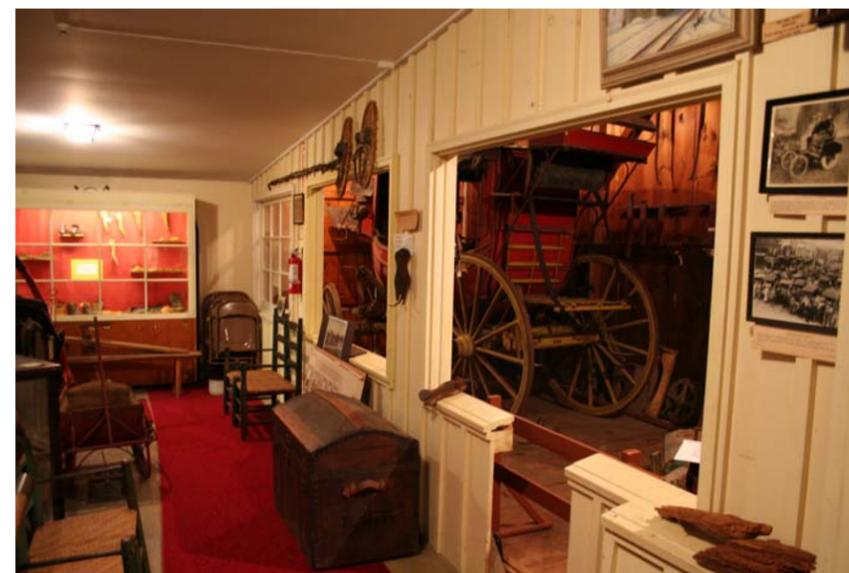
Image III- 36: The ca. 1873 Wadsworth Coach as it is displayed in the Coach House which does not provide a suitable environment for such a prominent piece of the collection.

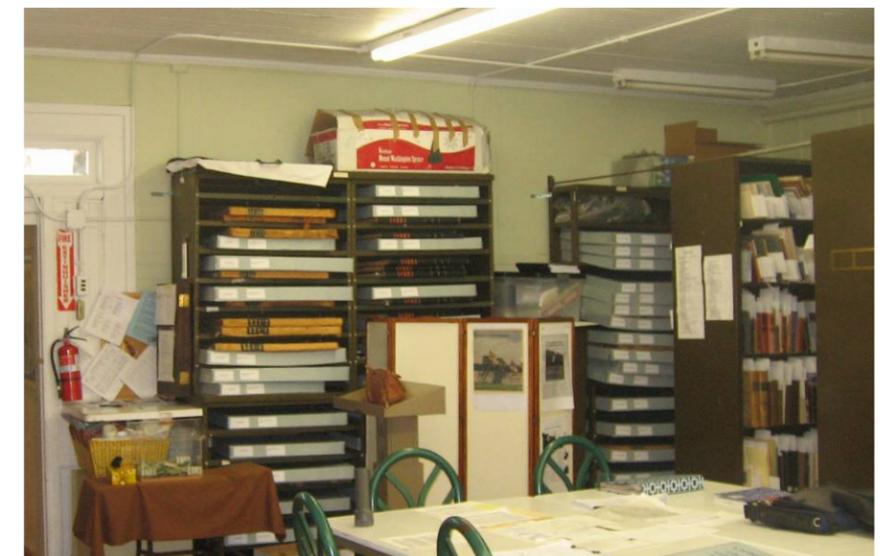
The Museum stores its collections in glass-fronted cabinets in the west corridor, in a small room beside the main office, in the furnace room, and in a small space off the furnace room. Access to the collections housed in these crowded spaces is

cumbersome in the extreme, and the collections are not stored by methods that meet archival standards or are space-efficient. Temperature, humidity and light control in the storage areas are also deficient.

Image III- 38: Overwhelmed storage in the 1871 addition that is currently used as an office environment.
