SUMMARY OF FINDINGS – EXTERIOR

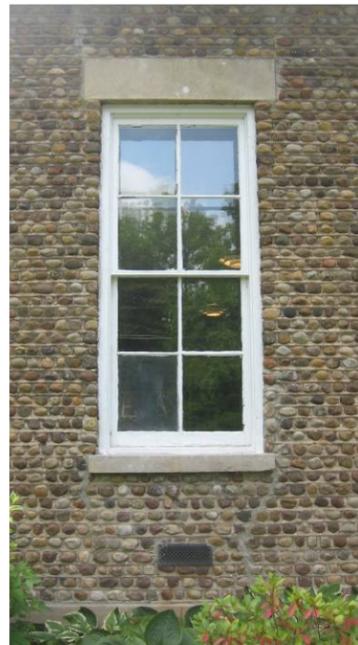
Image III – 18: Original Window - Exterior

The building retains its original wood, double hung windows in good overall condition, although many units are not in operable condition.

The wings of the schoolhouse would have originally had a single 2/2 double hung window at the north (front) facade. The original configured window is extant at the west wing, but was previously removed at the east wing. In 1916 a 4/4 configured unit was installed along with a new masonry window opening and 4/4 unit at the east wall of the east wing. These windows have exterior storm units. Overall the windows are in good condition, although the painted finish is worn and exhibits surface cracking. All but the north window have been sealed shut and do not currently open.

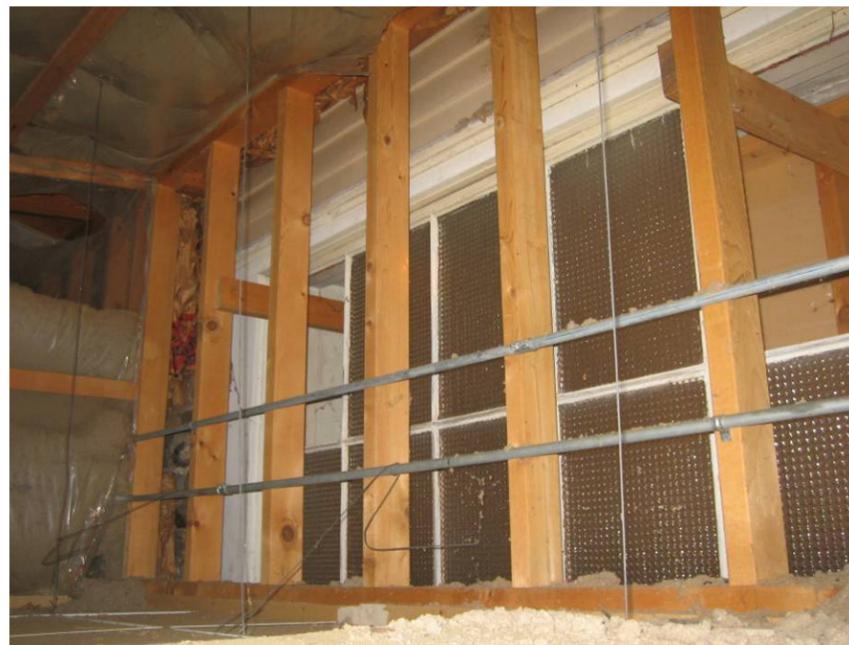
The main block has steel framed windows installed at the south (rear) wall ca.1930s. The windows are housed in wall construction of the Memorial Room addition, ca. 1968, partially viewable above suspended ACT ceiling. There are three 16-light steel framed units, with textured glass, housed in wood frame construction within the cobblestone masonry wall.

Image III- 20: Ca. 1930s steel framed sash windows on south elevation of main block visible above dropped ceiling of Memorial Room.
